72" RCP Dam Outfall Pipe Repair

Gainesville, GA

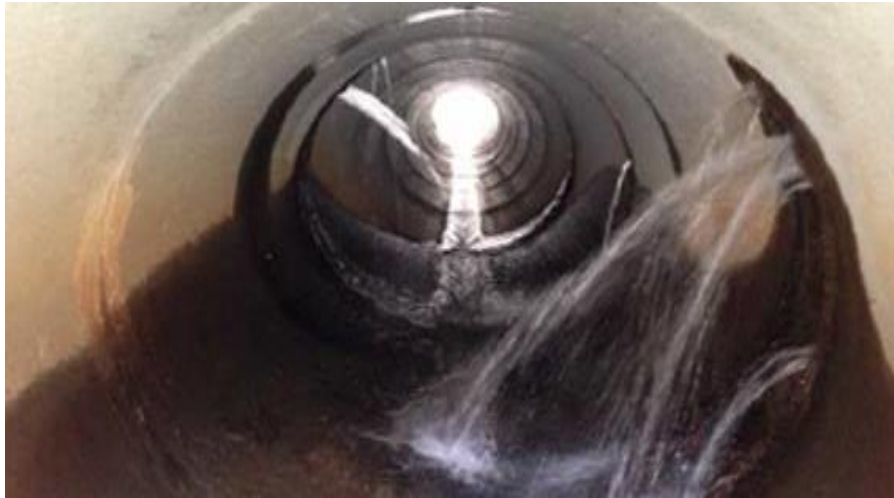
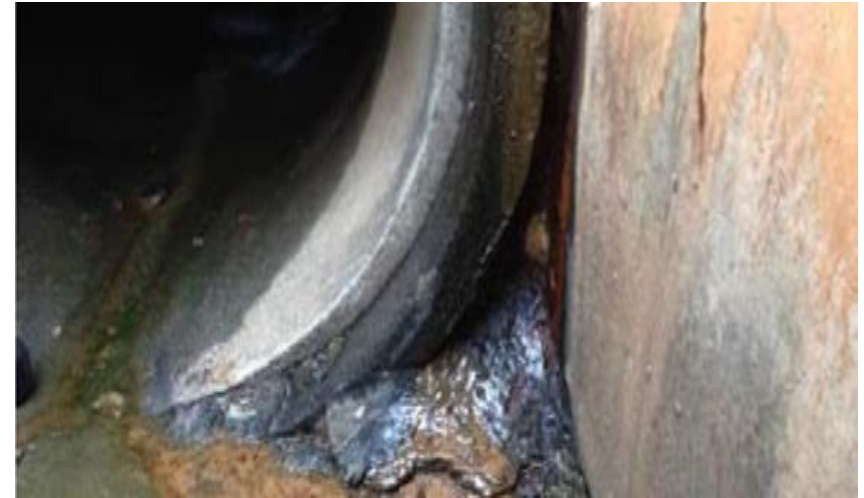
Project Challenges	Solution	Support	Outcome
<ul style="list-style-type: none"> 72" RCP dam outfall pipe had water flowing along the outside of the pipe and entering the weak pipe joints Customer did not want to remove / replace the RCP because was in good condition Customer tried cementitious grout to seal joints and failed (see cementitious grout attempt in pipe haunch of picture on right) 	<ul style="list-style-type: none"> Stabilize and densify surrounding soils, creating a non-permeable layer to stop water movement by use of Deep Injection of high density polyurethane Inject the Uretek 486 material to seal the leaking joints Injections made at 5 & 7 o'clock positions of the pipe 	<ul style="list-style-type: none"> Uretek designed the injection process using a hydrophobic 2 part Star 486 HDP material We were able to fix the joints from inside the pipe and did not need to close the road 	<ul style="list-style-type: none"> Quick Installation: Project took 6 hours compared to 4 days to remove and relay the RCP (would not have needed to replace). Cost Effective: Project was more cost effective than remove/relay and bringing in additional fill material. Also, slip lining was not a viable option since the water was coming from the outside of the pipe.
