# Manhole Infiltration Repair

## Clarksville, IN

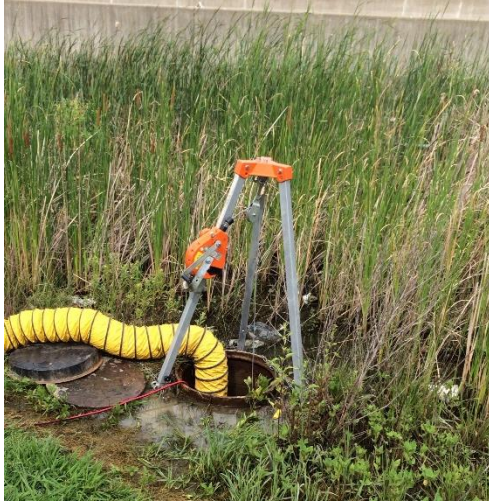
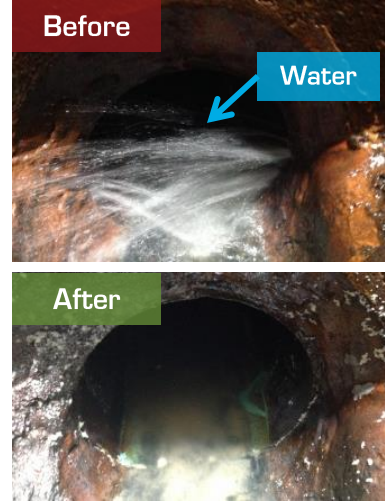
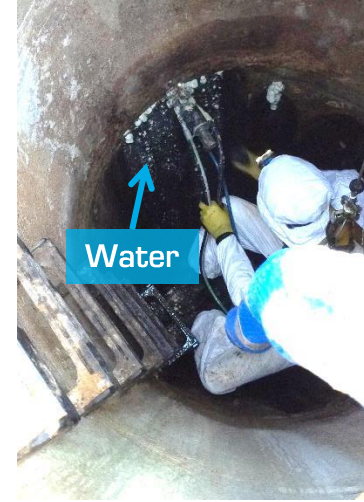
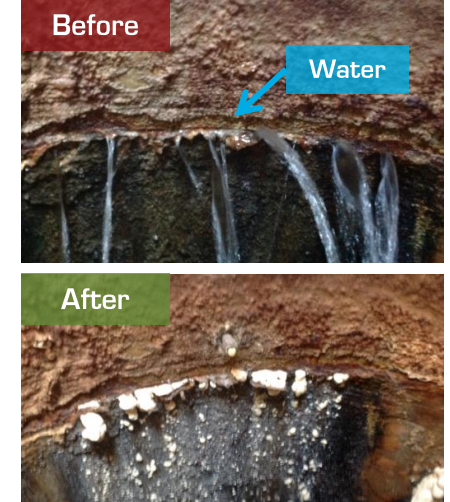
Project Challenges	Solution	Support	Outcome
<ul style="list-style-type: none"> <li>• TV inspection showed large amounts of Inflow and Infiltration (I&amp;I) in 7 manholes</li> <li>• I&amp;I caused flow to exceed pump station design</li> <li>• High ground water table (at grade in some locations)</li> <li>• Failure in structure joints and pipe to structure joints</li> </ul>	<ul style="list-style-type: none"> <li>• Inject URETEK 486Star Polymer directly through manhole walls and through base of structure, beneath pipe invert to fill voids and seal leaks</li> <li>• Where other methods failed, GWS successfully mitigated infiltration</li> </ul>	<ul style="list-style-type: none"> <li>• Designed injection quantity, depth, and location to address I&amp;I in the 12" sanitary manhole intersections as well as the structure joints</li> </ul>	<ul style="list-style-type: none"> <li>• Work completed in a day and a half</li> <li>• Stopped high pressure leaks in minutes</li> <li>• Significantly reduced I&amp;I flowing through sanitary system to pump station saving the City over \$90K per month</li> <li>• <b>Since repair, 49 pump hours per week reduced to 17</b></li> <li>• <b>Cost savings of \$100k per month since repair</b></li> </ul>
