Inflow and Infiltration Sealing

Gulf Breeze, FL

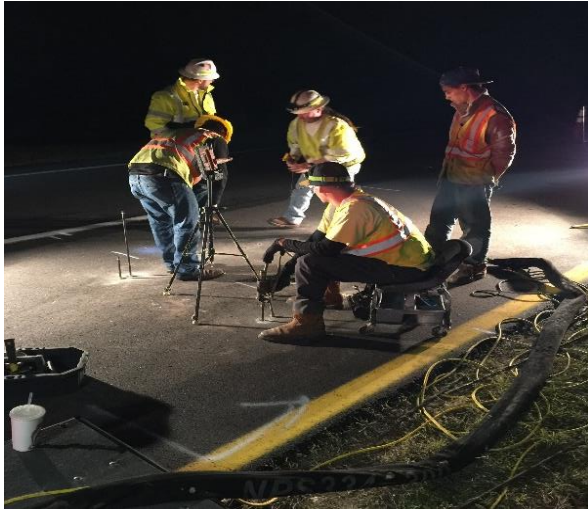
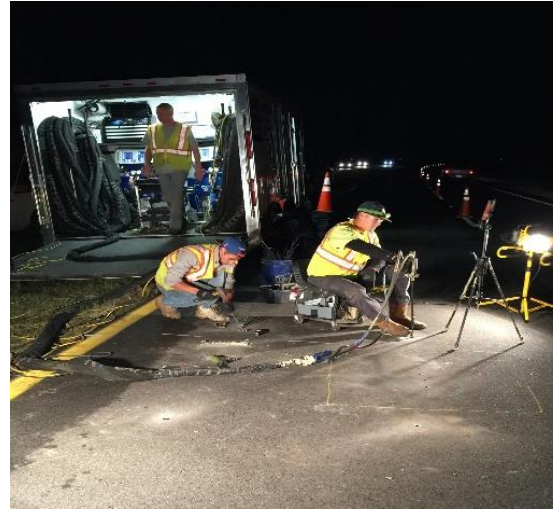
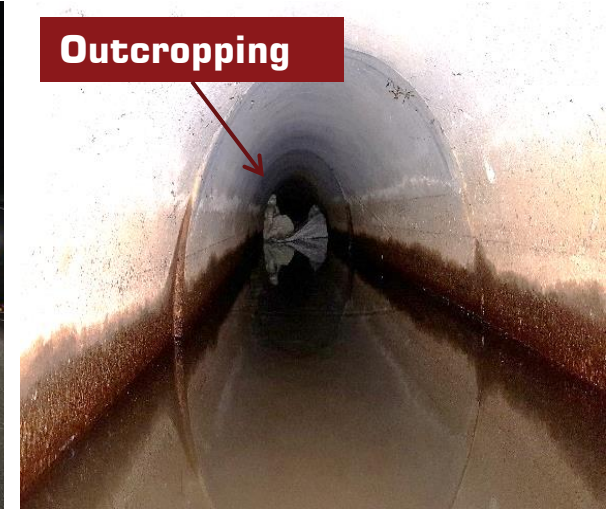
Project Challenges	Solution	Support	Outcome
<ul style="list-style-type: none"> Stormwater drained from surface drain in median to outfall in the shoulder. Crew unable to inject from inside pipe due to small diameter Faulty joint 20' from surface drain allowed soil fines to enter drain system and cause subsidence at surface. 	<ul style="list-style-type: none"> GWS crews used the patented Deep Injection Process to seal RCP and stabilize right of way. Working safely to produce high quality results is always the highest priority. Polyurethane was injected from road surface using a 4' grid pattern to seal and encapsulate exterior of the pipe and restore load bearing capacity to soil. 	<ul style="list-style-type: none"> APAC MidSouth assisted by providing a pre-construction site visit. APAC MidSouth also assisted by providing traffic maintenance. 	<ul style="list-style-type: none"> Minimal intrusion: No excavation was involved with sealing this infiltration leak. Infiltration Sealed: The leaking joint was completely sealed using lightweight, structural-grade polyurethane via the Deep Injection Process®
