Landfill Weight Station Slab Lift

Broome County, NY

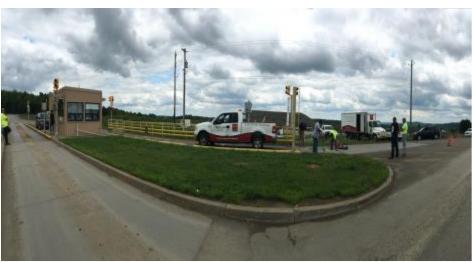
Project Challenges	Solution	Support	Outcome
 Weigh Station Approach and Departure Slabs had settled causing unsafe traffic conditions. Unknown Soil Conditions. Weight Station had to remain operational during the repairs. 	 DCP Testing was conducted to determine soil conditions. URETEK 486 STAR structural polymer was used to stabilize the subsoils. URETEK 486 STAR structural polymer was used to lift the slabs and align the joints. 	 Broome County Resident Engineer's Office. Broome County Landfill maintenance Department. ZMK Construction 	 Soil was stabilized to depths determined by the DCP Test results. The approach / departure slabs were lifted and aligned to create safe traffic conditions. All work was completed in less than 2 days.
