# Barrancas Avenue Pipe Joint Sealing

## Pensacola, FL

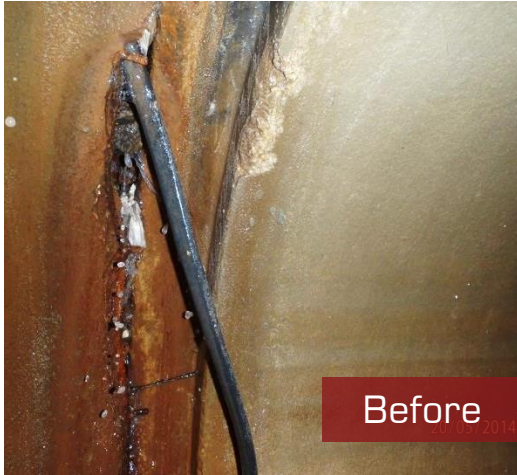
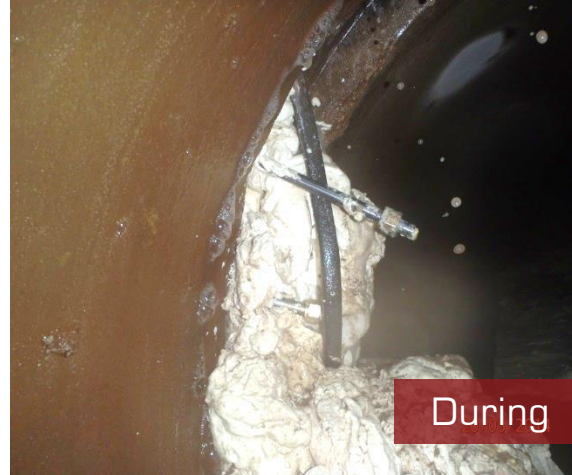
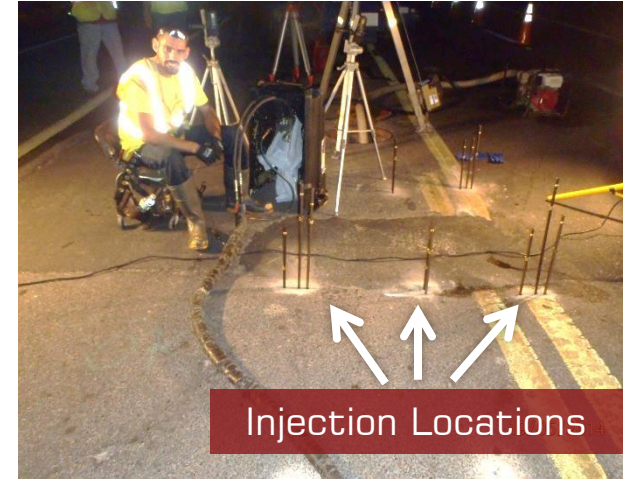
Project Challenges	Solution	Support	Outcome
<ul style="list-style-type: none"> <li>Joint failure due to stress caused by settled manhole structure and migrating base soils</li> <li>Inflow &amp; Infiltration into storm drain system</li> <li>Pavement settlement due to loss of bearing soils</li> </ul>	<ul style="list-style-type: none"> <li>Inject URETEK polymer through lateral line to encapsulate and seal leaking joint from inflow and infiltration</li> <li>Deep Injection Process at 3 distinct elevations to densify weak base soils and prevent additional pavement settlement</li> </ul>	<ul style="list-style-type: none"> <li>Pre-Estimate Meeting with Transfield Services</li> <li>Designed injection locations, quantities and depths</li> <li>Pre-construction meeting onsite with contractor and crew</li> <li>On-site installation</li> </ul>	<ul style="list-style-type: none"> <li><b>Minimal intrusion:</b> Work performed in 1 Night with no excavation or traffic delays</li> <li><b>Infrastructure Stabilization:</b> Stabilized and bridged bearing footprint of base soils</li> <li><b>Lateral Line Encapsulation:</b> Stabilized soils to support structure and sealed joint to prevent I&amp;I</li> </ul>
