# Bellevue Family YMCA Pool

## Bellevue, WA

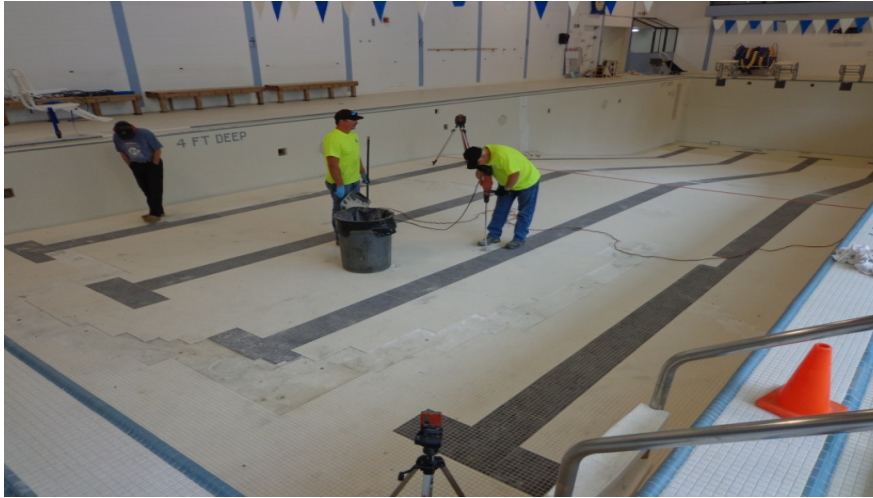
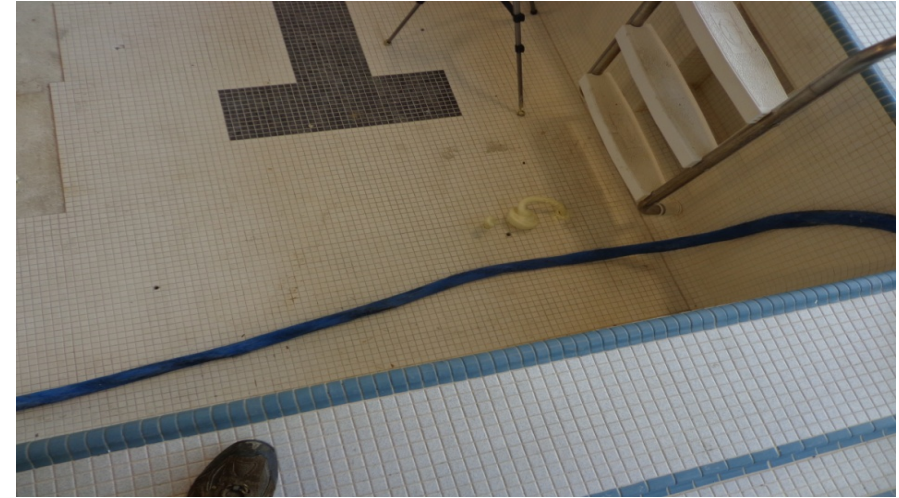
Problem	Challenges	Solution	Outcome
<ul style="list-style-type: none"> <li>• Unusually high water bills.</li> <li>• Cracks at the edge and between the small tiles.</li> <li>• Tiles were removed and cracks in the bottom were found.</li> <li>• 1" holes were drilled at the end of each crack indicated voids</li> <li>• Ground Works was called in to estimate repair costs.</li> </ul>	<ul style="list-style-type: none"> <li>• Work was to be completed in one day so that the remaining work could begin the next day.</li> <li>• At the beginning of the project we use the string line to show the pool had been constructed with a dip in the center to allow the pool to drain.</li> <li>• Minimize damage to the tiles to speed the balance of the repair to the bottom of the pool.</li> </ul>	<ul style="list-style-type: none"> <li>• A 4x4 grid pattern was drilled to accept method injections.</li> <li>• Injections were made using URETEK 486 GD to provide void filling ,support, and under seal to the bottom of the pool.</li> <li>• During the injection process materials often times surfaced in the adjacent holes.</li> <li>• The settlement of the center of the pool proved to be incorrect.</li> </ul>	<ul style="list-style-type: none"> <li>• Problem permanently solved in one work shift resulting in pool opening ahead of schedule.</li> <li>• No interruption Y's normal daytime activities.</li> <li>• Non-invasive solution resulted in minimal restoration for the pool</li> <li>• Close laser monitoring resulted the positive completion of the desired void fill and floor stabilization .</li> </ul>
