Bracco Pond Outfall – Void Fill

City of Cocoa – Cocoa, FL

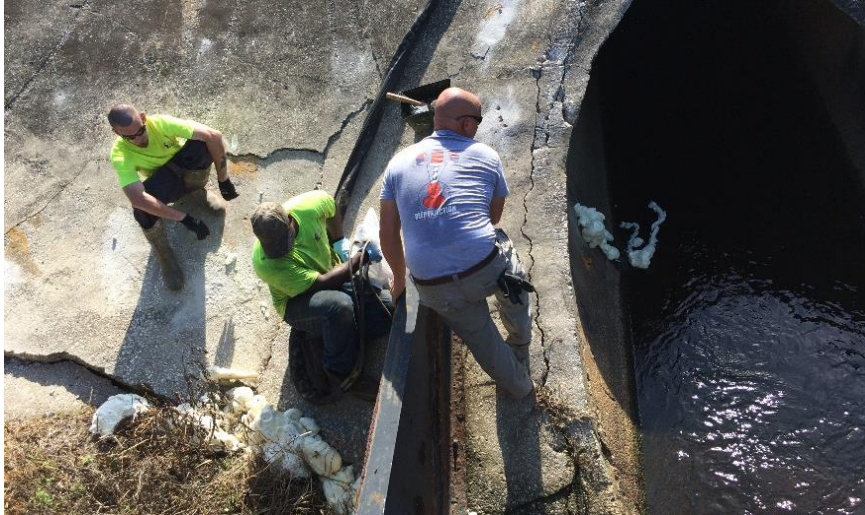
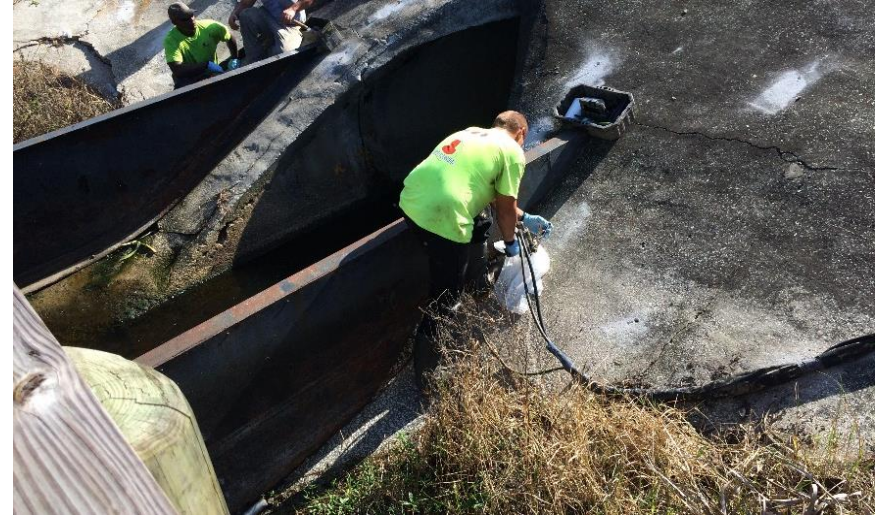
Project Challenges	Solution	Support	Outcome
<ul style="list-style-type: none"> Concrete slope pavement had significant elevation loss and the 1st joint of the RCP pipe failed, permitting water infiltration from embankment. Water infiltration caused soil erosion that created voids, ranging from 18" to 36" inches. 	<ul style="list-style-type: none"> Inject structural polymer under concrete slope pavement to fill voids and stabilize the structure to prevent collapse. Inject structural polymer to fill approx. 680 CF of void and seal 1 corrugated metal pipe. 	<ul style="list-style-type: none"> Designed injection plan Pre-construction meeting On-site installation Double impingement gun injection 	<ul style="list-style-type: none"> Problem Solved: One day installation resulted in void space being filled, slope pavement stabilized, and 1 joint sealed to customer satisfaction. Minimal impact: Work completed ahead of schedule
