Brevard County Lift Station

Brevard County, FL

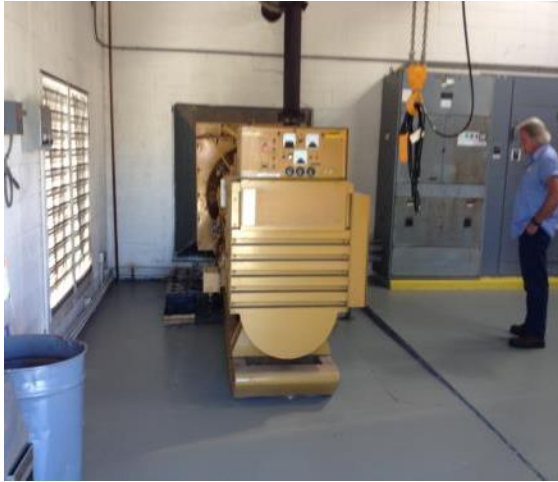
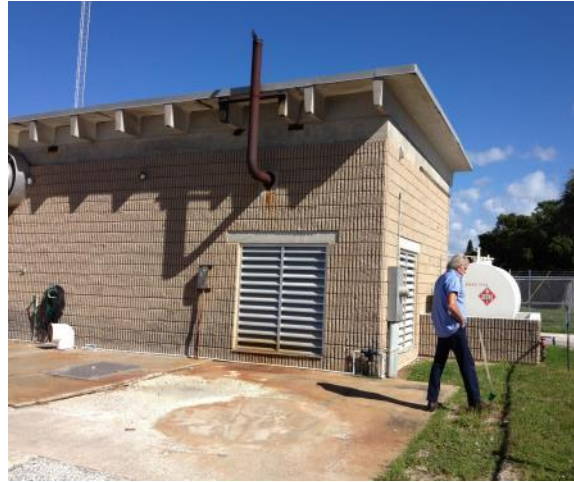
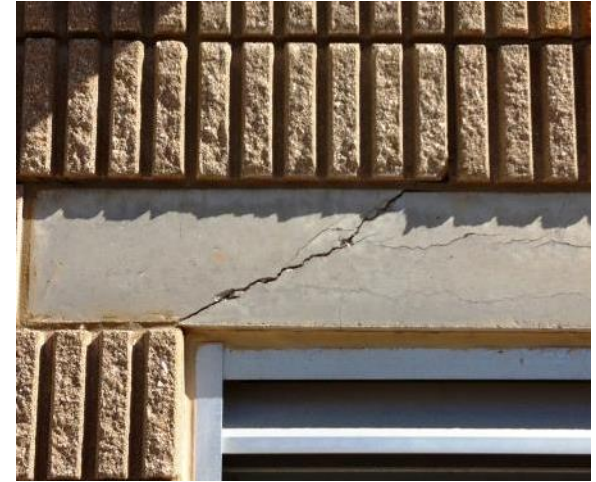
Project Challenges	Solution	Support	Outcome
<ul style="list-style-type: none"> Poorly compacted soil and sodium hydroxide leak (used to combat odor) caused the generator and exterior concrete slab to settle and compromising the interior and exterior of the building 	<ul style="list-style-type: none"> Inject URETEK polyurethane under the interior/exterior slab and compromised exterior walls to stabilize soils Injection points at various locations and depths using specific pounds of material 	<ul style="list-style-type: none"> Specifications from an outside engineering firm and Brevard County Designed injection points quantity and depth On-site installation 	<ul style="list-style-type: none"> Minimal downtime: All work performed in one day Stabilized soil: Extend the life of lift station resulting in a cost savings for Brevard County
