# CSX – US60 Railroad Crossing Huntington, WV

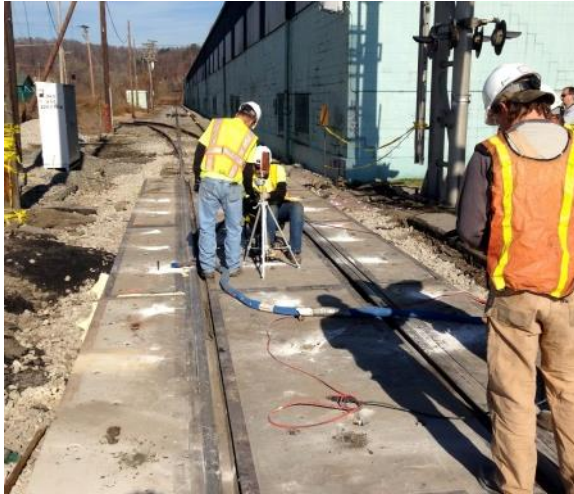
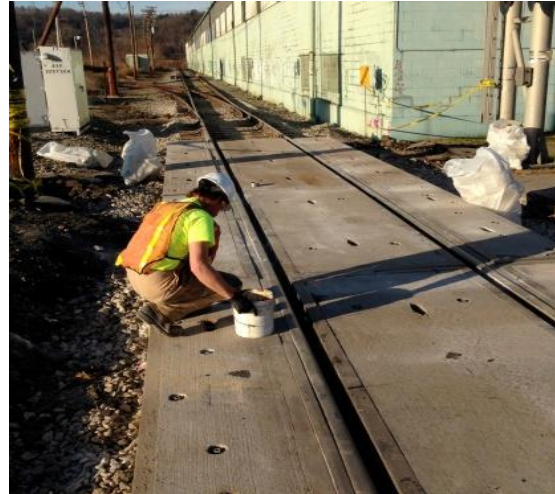
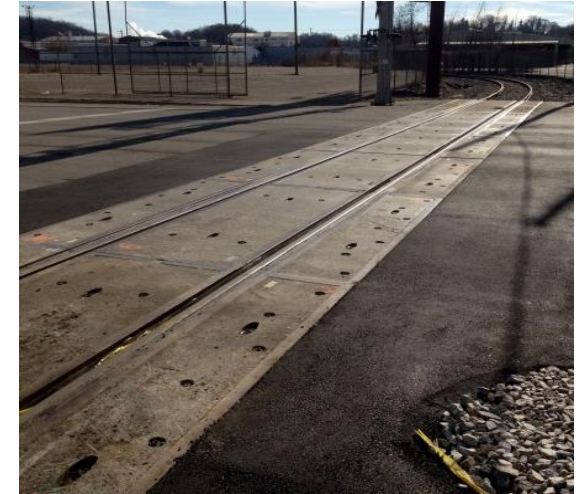
Project Challenges	Solution	Support	Outcome
<ul style="list-style-type: none"> <li>• Water infiltrating the foundation</li> <li>• Rail settlement</li> <li>• Voids underneath the slabs cause rocking when traffic passed</li> </ul>	<ul style="list-style-type: none"> <li>• Inject URETEK polyurethane from surface to fill voids and stabilize soils</li> <li>• Injection ports at various locations and depths</li> <li>• Ballast tamped into place under the rail (by others)</li> </ul>	<ul style="list-style-type: none"> <li>• Specifications</li> <li>• Designed injection port quantity and depth</li> <li>• Pre-construction meeting</li> <li>• On-site installation</li> </ul>	<ul style="list-style-type: none"> <li>• <b>Minimal downtime:</b> All work performed in one day</li> <li>• <b>Stabilized soil:</b> Rail and precast panels remain stable when traffic travels by</li> </ul>
