# Egret's Nest Double Box Culvert Jacksonville, FL

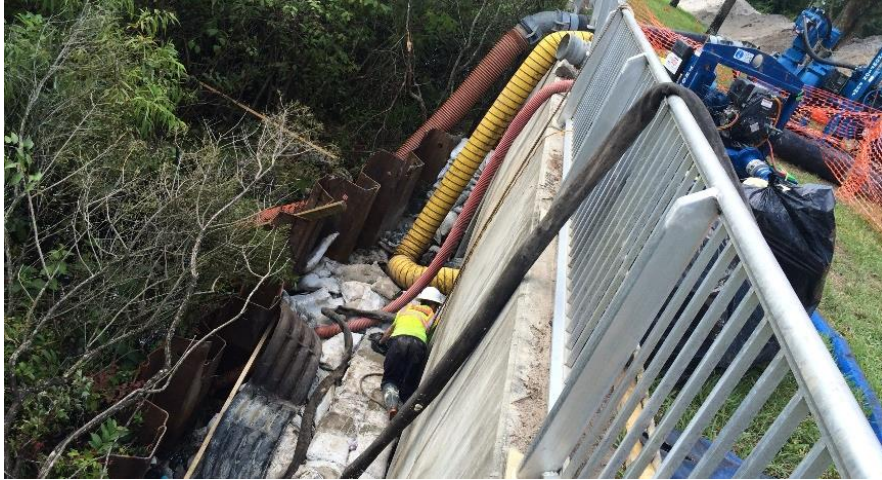
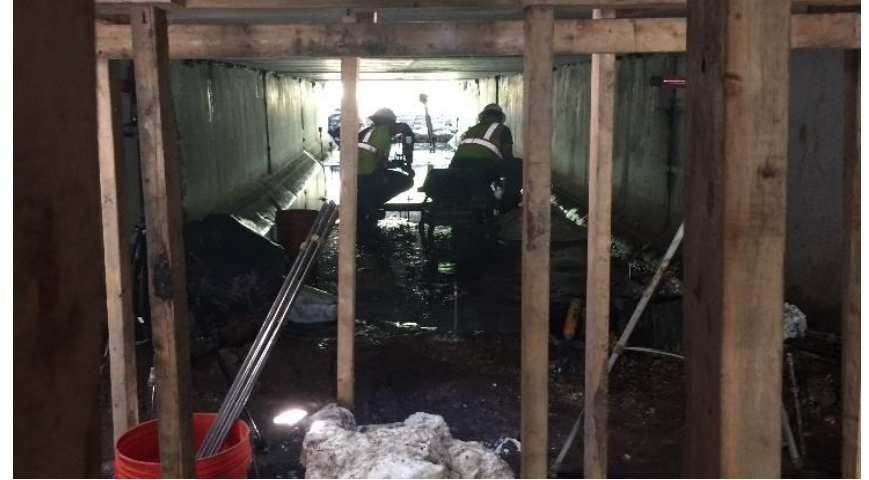
Project Challenges	Solution	Support	Outcome
<ul style="list-style-type: none"> <li>• Soil erosion, caused by poor construction and leaky joints, has occurred above and below double culvert.</li> <li>• Soil erosion has caused a partial collapse of the culvert and threatens to collapse 10 other sections.</li> </ul>	<ul style="list-style-type: none"> <li>• Inject structural polymer from the inside of the culvert to fill voids and stabilize the structure to prevent further collapse.</li> <li>• Inject structural polymer to seal 8 culvert joints, and inject 50+ deep injections @ -2ft approx. 55lbs per point.</li> </ul>	<ul style="list-style-type: none"> <li>• City of Jacksonville</li> <li>• Auld &amp; White - Engineer</li> <li>• Designed injection plan</li> <li>• Forced-air ventilation</li> <li>• Pre-construction meeting</li> <li>• On-site installation</li> </ul>	<ul style="list-style-type: none"> <li>• <b>Problem Solved:</b> 4 day installation resulted in void space being filled, 10 culvert sections stabilized, and 8 joints sealed to customer satisfaction.</li> <li>• <b>Minimal impact:</b> Work performed within time frame</li> </ul>
