Holston Army Ammo Plant - Pond Kingston, TN

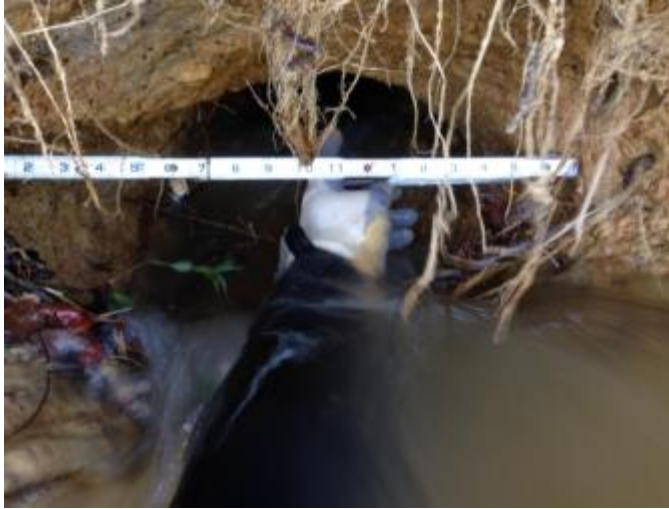
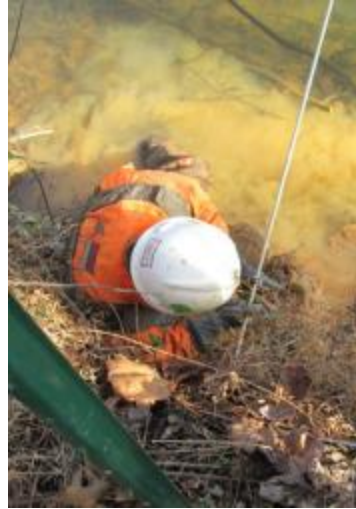
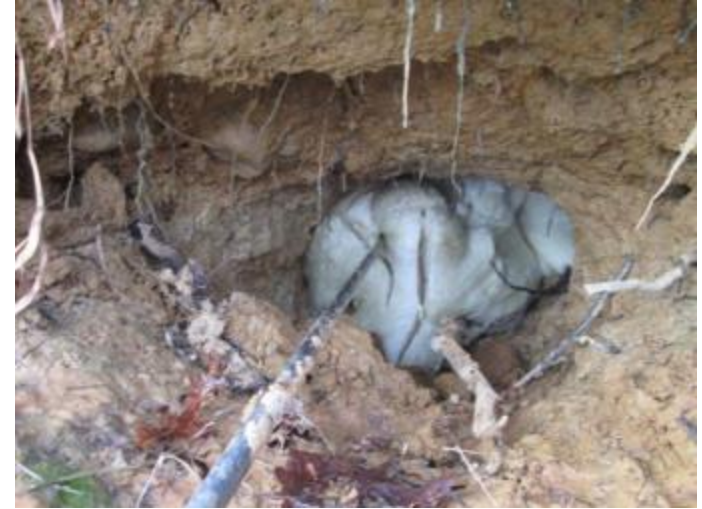
Project Challenges	Solution	Support	Outcome
<ul style="list-style-type: none"> Water flowing through earthen dam of cooling water reservoir. Customer had dropped level of pond to mitigate unwanted flow, which reduced storage capacity of cooling water in case of emergency. 	<ul style="list-style-type: none"> Fill void and plug path of water seeping out of pond. Use the URETEK Deep Injection® Process to place material directly into discharge location to plug the leak. Use the URETEK Deep Injection® Process to create a seepage barrier around the discharge location to cut off any secondary paths that might develop. 	<ul style="list-style-type: none"> Early site visit, prior to identification of leak location. Investigation of scanning technologies to help identify void areas. Compliance with federal purchasing requirements and site safety/security requirements. 	<ul style="list-style-type: none"> Fast Repair: The leak was stopped in 1 day. Reservoir Capacity Restored: The customer was able to raise the pond back to normal level. 29% Under Budget.
