Hwy 61 – Emergency Sinkhole Repair

Natchez, MS

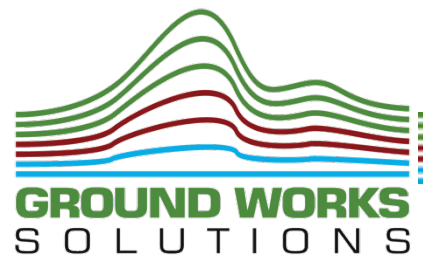
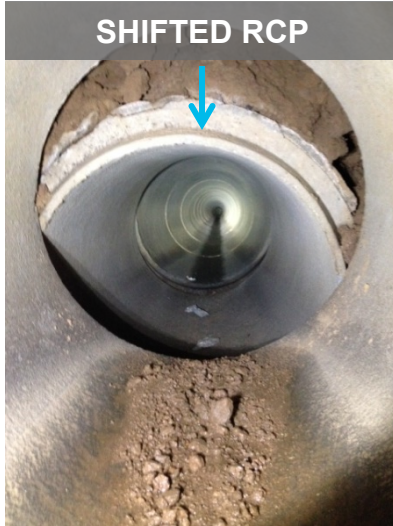
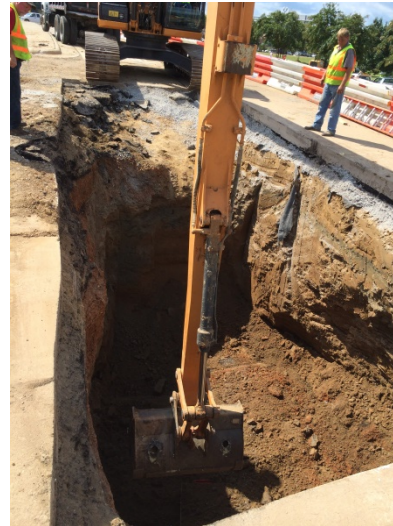
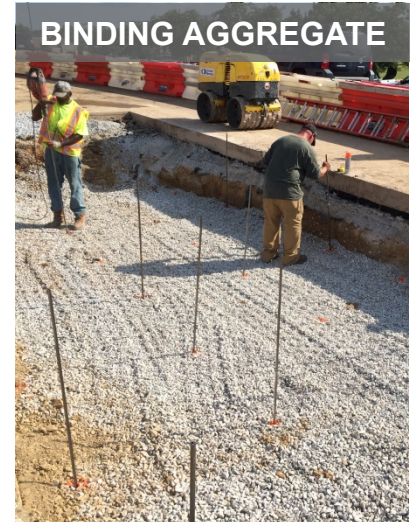
Project Challenges	Solution	Support	Outcome
<ul style="list-style-type: none"> Sinkhole formed on HWY61 in Natchez, MS 24" RCP misaligned due to a leaky joint that degraded the support soils and caused voids beneath the pipe The RCP shifted and caused a sinkhole that shut down a portion of the highway route to a nearby hospital 	<ul style="list-style-type: none"> Mechanically align the pipe utilizing a trackhoe Stabilize and seal the pipe utilizing URETEK's Deep Injection method Fill excavated area with #57 stone aggregate and stabilize the aggregate at every 4-5ft of fill 	<ul style="list-style-type: none"> Specifications Utility locates Pre-construction meeting MDOT construction support Emergency Response 	<ul style="list-style-type: none"> Sealed and rehabilitated stormwater drainage system Stabilized support soils: bound #57 aggregate to form a solid monolithic mass below highway Quick Installation: Project was completed over 2 Days
