Kent State University Dam

Kent, OH

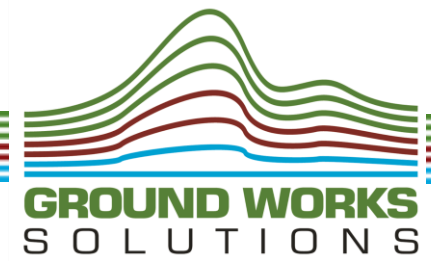
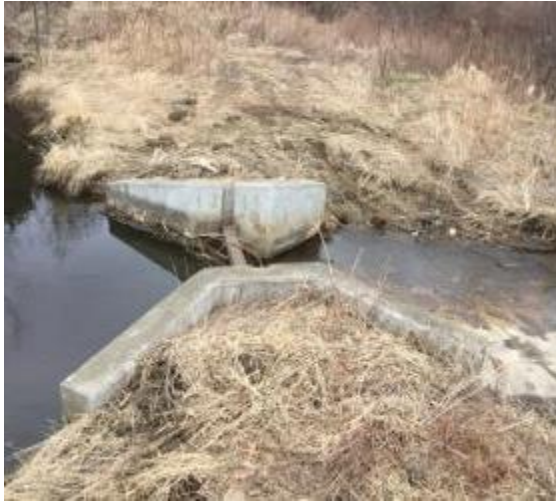
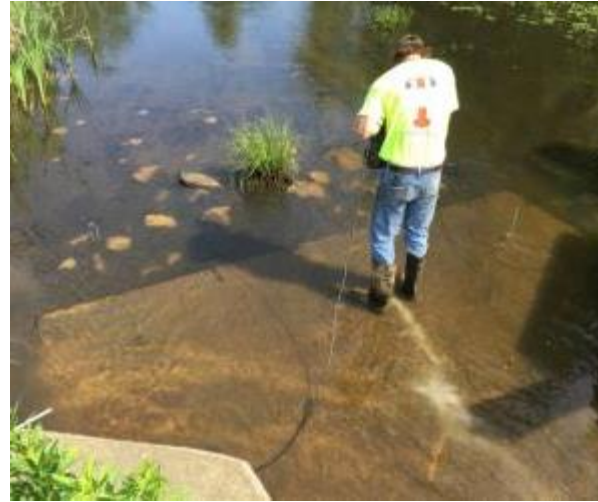
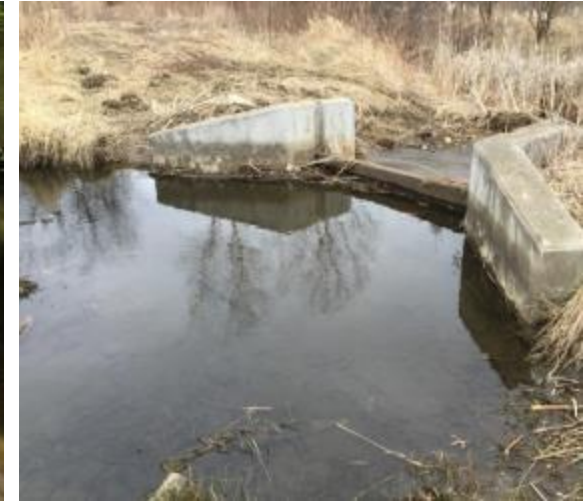
Project Challenges	Solution	Support	Outcome
<ul style="list-style-type: none"> Prevent water from undermining the dam structure Periods of high water flow caused soil erosion under the inflow pad Work was performed while the dam was under water 	<ul style="list-style-type: none"> Lay out containment booms and reduce water flow prior to injections Material injected into the inlet slab soils Injection point locations adjusted as material redirected water flow over the dam 	<ul style="list-style-type: none"> Kent State University provided cleared access and MOT The University's environmental director observed the repair 	<ul style="list-style-type: none"> No downtime: All work performed in one day. No Service disruption: water was not back up and the dam was never taken offline Successful repair resulting in preserving the wetland area
