# Manhole B-8, Neyland Drive Knoxville, TN

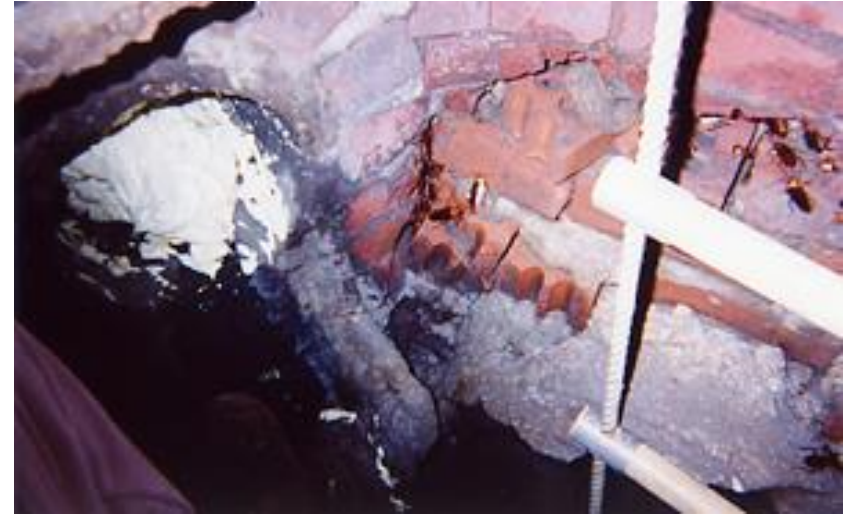
Project Challenges	Solution	Support	Outcome
<ul style="list-style-type: none"> <li>• Sheared 8" lateral line was causing extensive voids and loose soil around manhole</li> <li>• 25' Manhole was under threat of collapse</li> <li>• Stabilize manhole without collapsing</li> </ul>	<ul style="list-style-type: none"> <li>• Inject around the perimeter of manhole and stabilize loose soils and the manhole, utilizing strict penetrometer measurement</li> <li>• Fill 75' of 8" line</li> </ul>	<ul style="list-style-type: none"> <li>• Specifications</li> <li>• Designed injection port quantity and depth</li> <li>• Pre-construction meeting</li> <li>• On-site installation</li> </ul>	<ul style="list-style-type: none"> <li>• <b>Minimal downtime:</b> All work performed in one day</li> <li>• <b>Stabilized soil:</b> Stabilized brick manhole and avoided roadway settlement. Additionally sealed the perimeter from further water intrusion.</li> </ul>
