# Trikeenan Tileworks - Commercial

## Hornell, NY

### Foundation Stabilization and Void Filling to Prevent Future Settlement

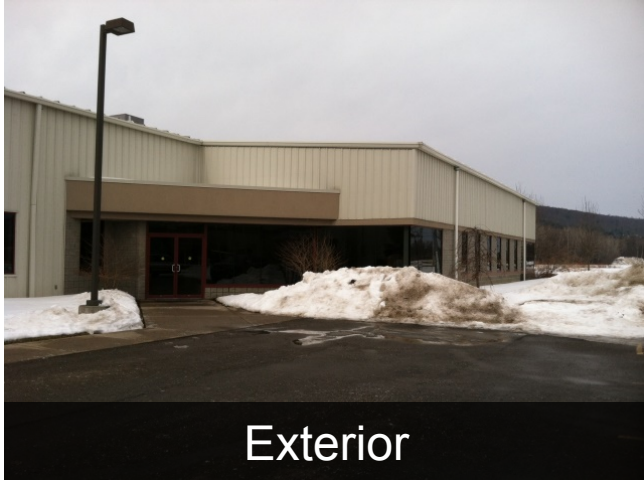
Exterior

Project Challenges	Solution	Support	Outcome
<ul style="list-style-type: none"> <li>• Incomplete downspouts causing discharge at footing location</li> <li>• 14' of poor soils</li> <li>• Improper shallow footer on perimeter</li> <li>• Old stream bed location</li> <li>• Tight working conditions since building occupied</li> </ul>	<ul style="list-style-type: none"> <li>• Undersealing and stabilizing shallow footer -182' along front and 26' along side</li> <li>• Deep injection at footer location at two different depths for both footer and poor soil stabilization</li> <li>• Void fill and lift interior slab to realign doorways and walls</li> </ul>	<ul style="list-style-type: none"> <li>• Worked with industrial group, engineer, and tile company for injection plan and schedule</li> <li>• City checked drain pipes for leaks</li> </ul>	<ul style="list-style-type: none"> <li>• Six solid days of work</li> <li>• Able to get bump on footer and minor lift; stabilization accomplished</li> <li>• Void fill under interior slab</li> <li>• Lifted interior slab allowing doorways to function properly</li> </ul>

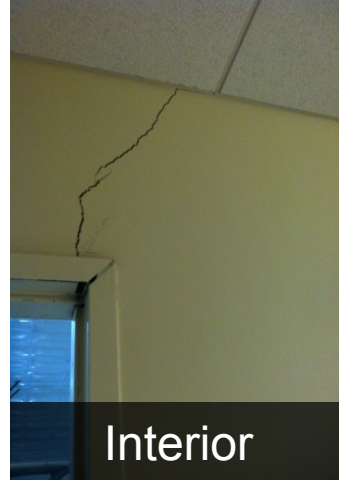
Interior

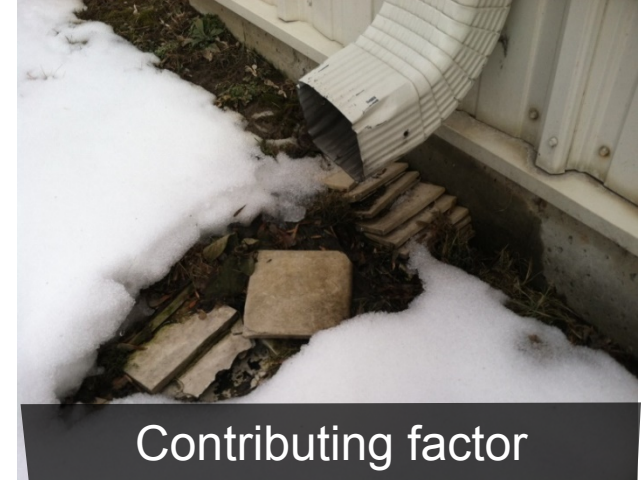
Contributing factor
