Univ. of Tennessee – Steam Plant

Knoxville, TN

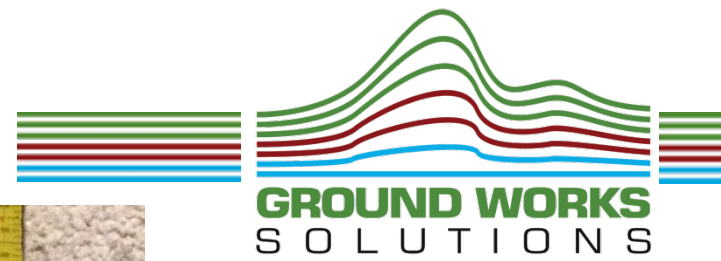
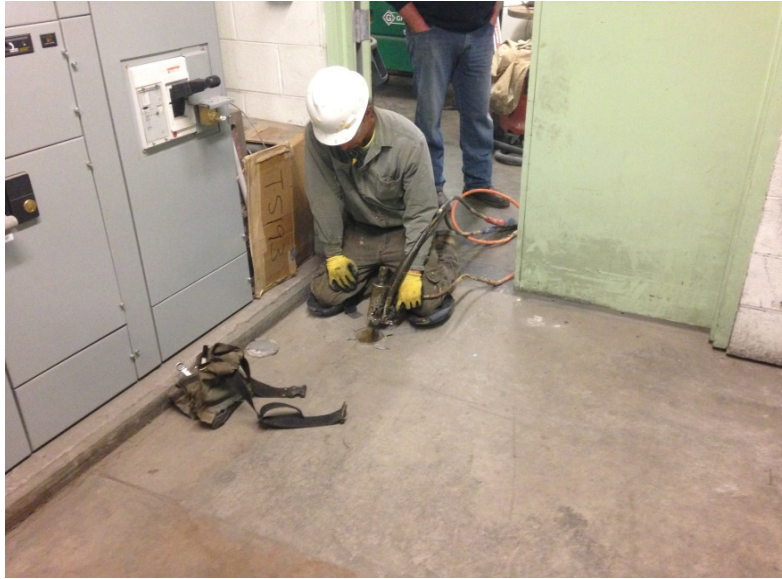
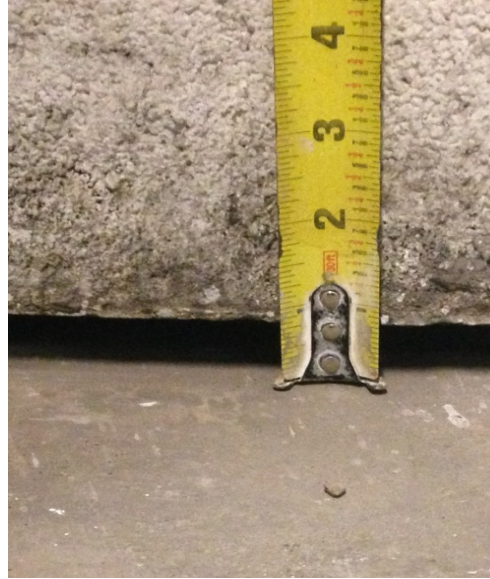
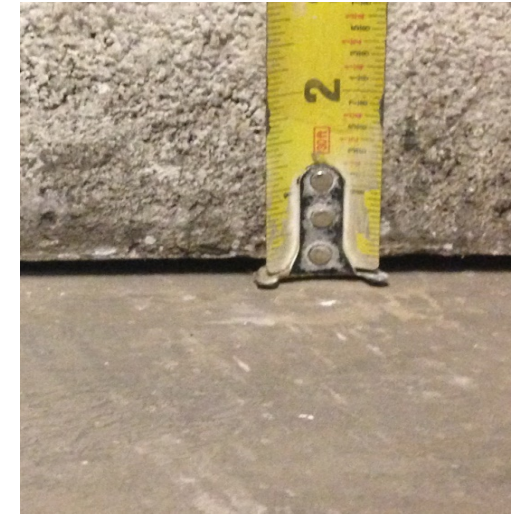
Project Challenges	Solution	Support	Outcome
<ul style="list-style-type: none"> • Slab in Motor Control Center room had settled and upto 5” voids discovered. Doors were binding, jeopardizing access in an emergency. • Heat from electrical equipment caused supporting clay soils to dry out and shrink excessively. • Steam plant under continuous operation. 	<ul style="list-style-type: none"> • Fill Voids and Lift Slab. • Use the URETEK Method to fill voids directly below the slab in order to stabilize and mitigate future settlement. • Lift the slab to re-level the doorframe and unbind the doors. 	<ul style="list-style-type: none"> • Review geotechnical engineer’s report and consult with GC. • Provide proposal with multiple options and recommendations for GC to present to the University. 	<ul style="list-style-type: none"> • Fast Repair: Work performed in a half of a day. • Slab Stabilized: The operation filled the voids and stabilized the slab. • Slab Lifted: The slab was lifted with special attention given to leveling the doorframe, which unbound the door and restored access to the MCC room.
