COSTCO #357 – Void Fill & Slab Lift

Jacksonville, FL

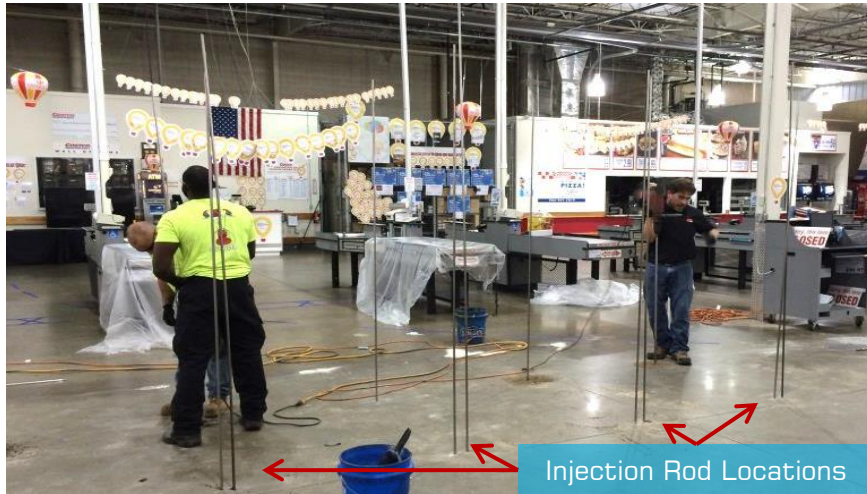
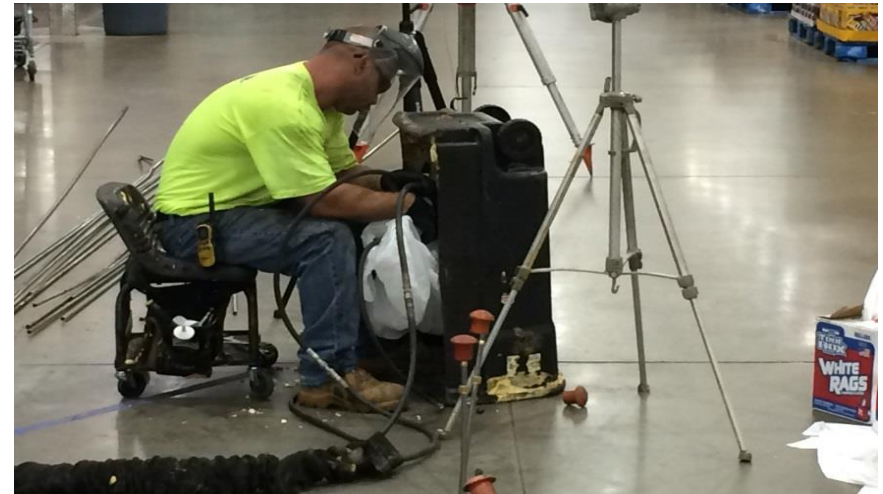
Project Challenges	Solution	Support	Outcome
<ul style="list-style-type: none"> • Appearance of circular cracking on concrete slab. Slab depressed up to 2.5". Soil boring data showed up to 3" void beneath slab. • Debris pits buried at depths ranging from 8ft to 16ft below slab. • Buried debris consisted of mostly organic materials (e.g. trees). 	<ul style="list-style-type: none"> • Inject structural polymer into debris pit to fill voids and create a stable mass 8ft to 16ft below the cash register area. • Inject structural polymer into void area, 150 cubic feet, directly below slab. Lifted slab back to grade. 	<ul style="list-style-type: none"> • Designed injection plan • Ground Penetrating Radar (GPR) to locate the voids • Pre-construction meeting • On-site installation 	<ul style="list-style-type: none"> • Problem Solved: Four day (night-time only) installation resulted in slab being lifted to customer satisfaction and debris pits being stabilized. • Mitigated Expense: prevented COSTCO from shutting down store operation, and saved them approximately \$1.5M in lost revenue.
