KMART Store Slab Lift

Poughkeepsie, NY

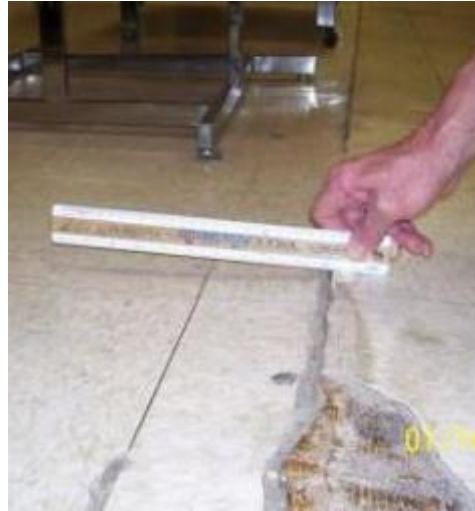
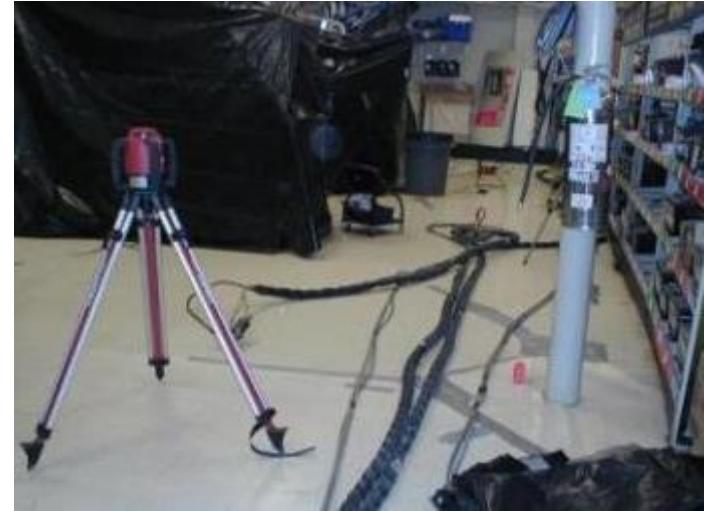
| Project Challenges | Solution | Support | Outcome |
|--|---|--|--|
| <ul style="list-style-type: none"> Slab settlement in the mechanical rooms, loading dock and customer display areas created an unsafe retail environment for both customers and store associates. Over six inches of slab settlement had to be lifted throughout a 1,200 sq. ft. area. | <ul style="list-style-type: none"> Inject structural geopolymer to underseal the slab, void fill, stabilize and lift. Constant monitoring with laser level to ensure proper lift. | <ul style="list-style-type: none"> Project Management performed by Kmart facility manager. Pre-construction/safety meeting between Kmart management and URETEK Holdings' construction foreman. | <ul style="list-style-type: none"> Problem Solved: 2 day installation resulted in stabilized base soils, void fill and full lift. No interruption to Operations: Retail business continued throughout installation. Non-invasive: injected polymer through 1/2" tubes with 5/8" holes per location. No excavation and patched holes. |
