Shipyard Machine Shop

Newport News, VA

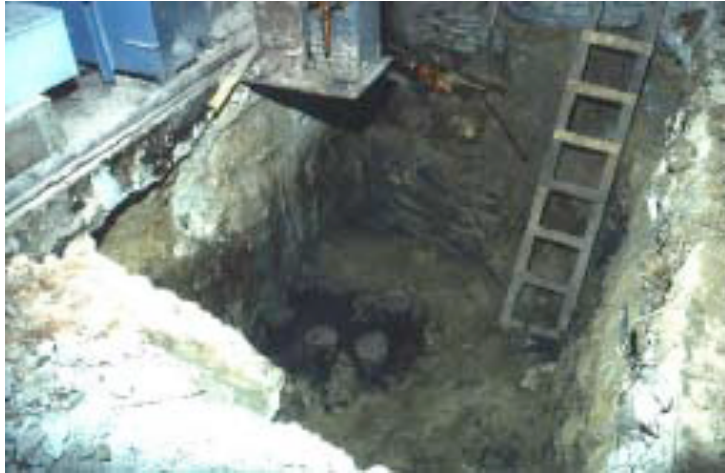
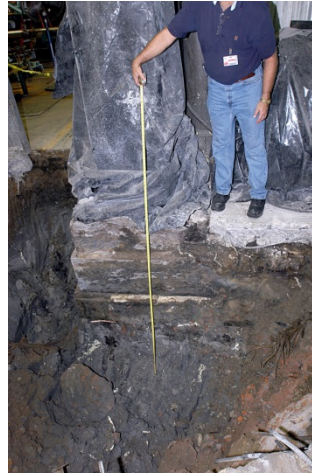
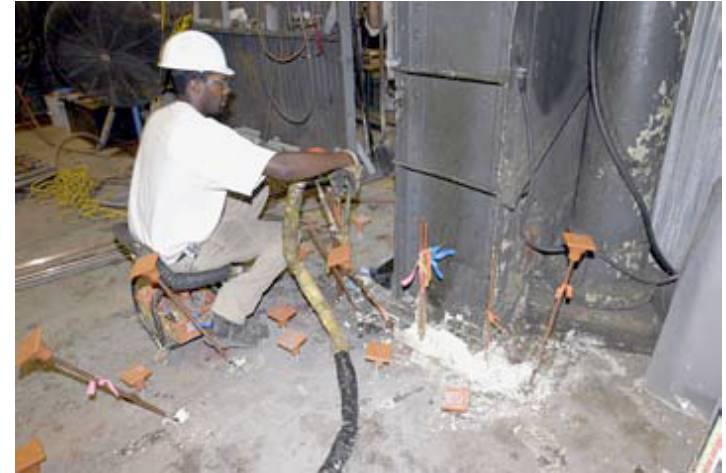
Project Challenges	Solution	Support	Outcome
<ul style="list-style-type: none"> • Various amounts of settlement in columns and slabs. • Differential settlement damaged structural components and pulled cranes out of alignment. • Buried wood sills and untreated wood piles. • Building constructed between 1890 – 1910. 	<ul style="list-style-type: none"> • Inject using the URETEK Deep Injection Process™ for a minimally disruptive, zero excavation stabilization. • Multiple elevations were injected under both static and dynamic loads. 	<ul style="list-style-type: none"> • Designed injection plan to support the columns and transfer imposed loads through the zone where the piles had failed. • DCP tests ran pre-injection, between static and dynamic loading injections, and after all injections. 	<ul style="list-style-type: none"> • Minimal downtime: Work was sequenced and completed with very little disruption. • Columns were stabilized, with DCP analysis to demonstrate the increased bearing capacity.
