USPS Post Office & Regional Sorting Facility

Berkley, WV

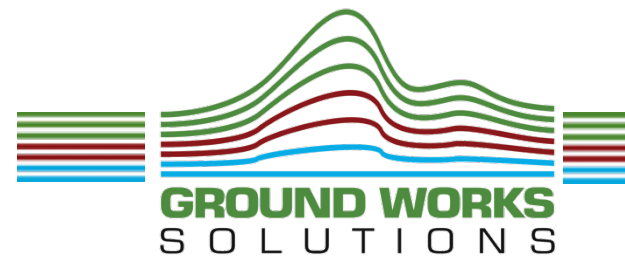
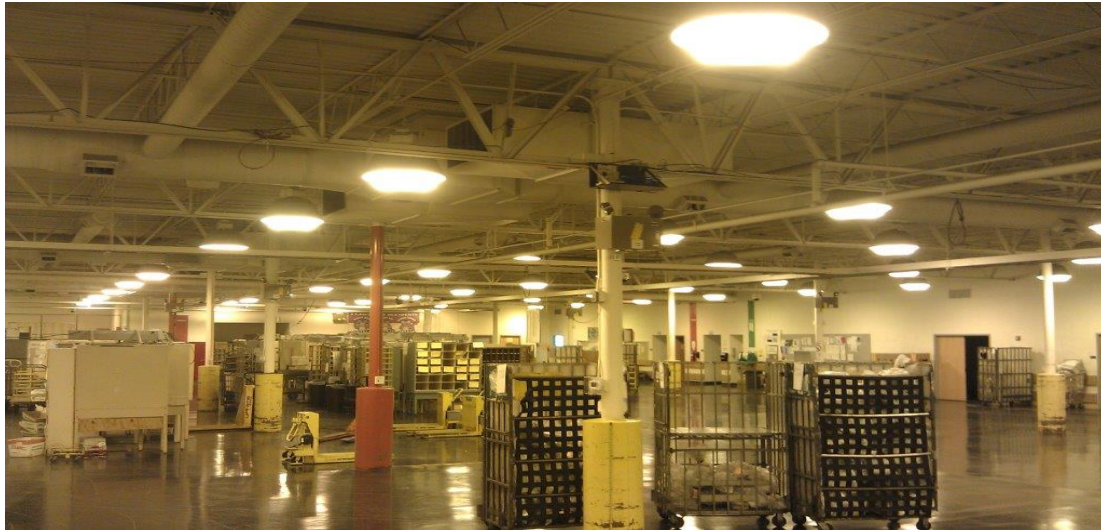
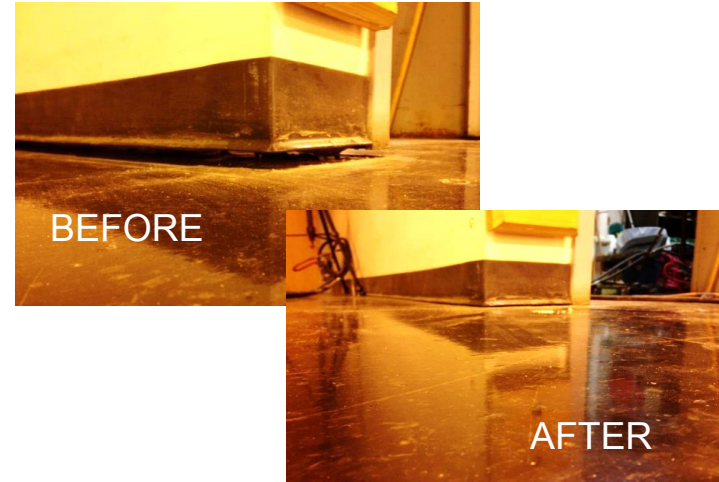
Project Challenges	Solution	Support	Outcome
<ul style="list-style-type: none"> • Approx 3,000 sf of slabs with up to 3" settlement and 6" voids • Poorly compacted mine spoils were used as fill for a portion of the building's footprint • Footings were supported by piles and grade beams. Voids and settlement in between 	<ul style="list-style-type: none"> • Inject URETEK's polyurethane to: • Fill voids beneath slabs • Raise slabs • Stabilize slabs • Realign door frames (where possible) • Raise walls bearing on slabs 	<ul style="list-style-type: none"> • Pre-estimate meeting with USPS, Geotech and GC • Work to be completed to not disturb 24-hour facility • Progressive monitoring of material used and projections to complete as much as possible in phases on limited budget 	<ul style="list-style-type: none"> • Minimal intrusion: Work performed with no disruption to business operations • Lift: Slabs were returned to original elevation. Additionally, door frames were realigned, and cracks in demising and partition walls were closed
