# Wells Fargo – Void Fill and Underseal

## West Palm Beach, FL

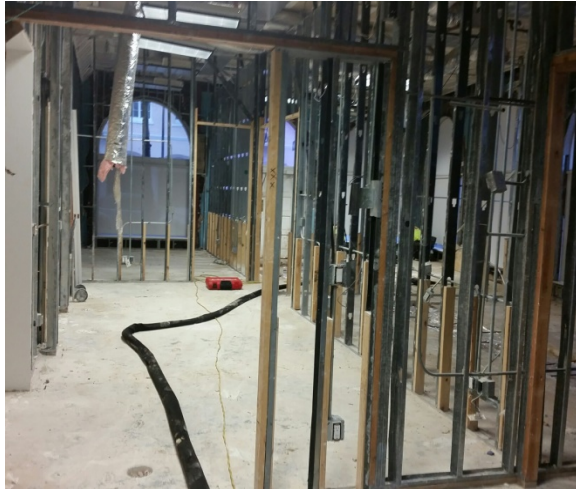
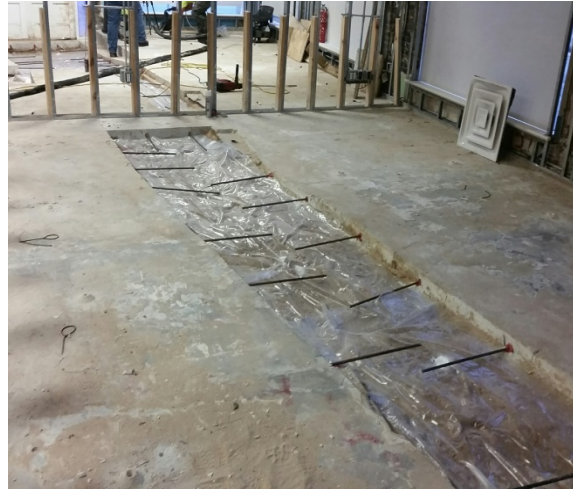
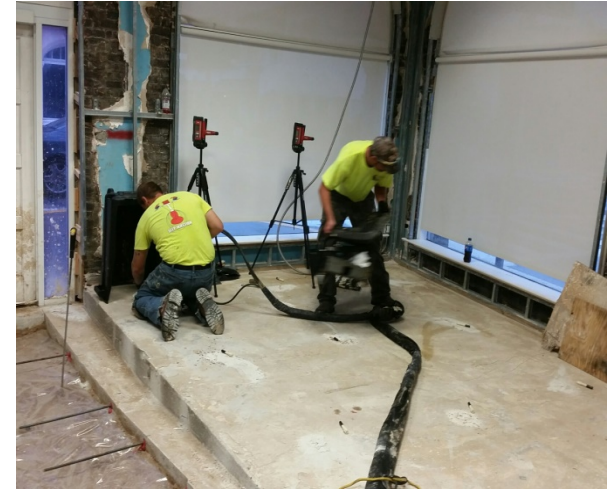
Project Challenges	Solution	Support	Outcome
<ul style="list-style-type: none"> <li>• 4' water line broke causing up to 1" voids throughout the 4,500 SF office space.</li> <li>• Void-fill and underseal 9" slab with wire mesh.</li> </ul>	<ul style="list-style-type: none"> <li>• Utilize multiple injection points to underseal the slab, and void fill</li> <li>• Utilize The URETEK Method throughout the problem areas.</li> </ul>	<ul style="list-style-type: none"> <li>• Self-designed solution based on site visits and Geotechnical findings by Ardaman and Associates and CBRE</li> <li>• During installation, monitored the injection process through laser equipment</li> </ul>	<ul style="list-style-type: none"> <li>• <b>Minimal intrusion:</b> Completed work in 1 day with no downtime or interruptions to customer's operations and construction.</li> <li>• <b>Customer Satisfaction:</b> Stabilized and filled voids to standards that helped exceed customer expectations.</li> </ul>
