Hills Pet Nutrition Distribution Center

LaVergne, TN

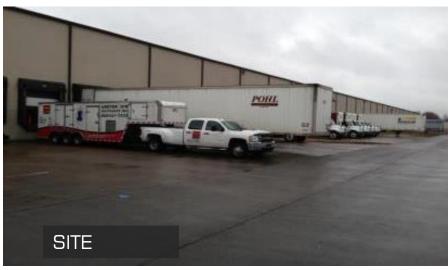
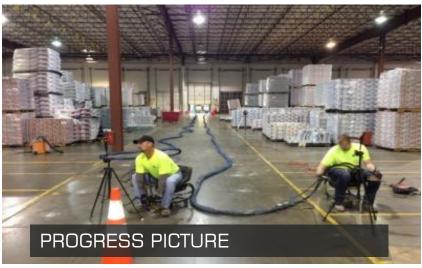
Project Challenges	Solution	Support	Outcome
 Rocking slabs when forklifts cross Constant forklift loading traffic No downtime allowed Only other options included long downtime and interruption 	Inject URETEK polyurethane to: • Fill voids beneath slabs • Underseal slabs • Stabilize slabs	 Pre-Estimate Meeting with Landlord and Tenant Weekend work to minimize disruption Live tests by tenant forklift operator to check slabs after injection 	 Minimal intrusion: Work performed in 5 hours with no disruption to business operations Quick Cure: Open to traffic in 15 minutes Under Budget: 40% under estimated budget
