Hillsborough Co. Evershine Lift Station

Tampa, FL

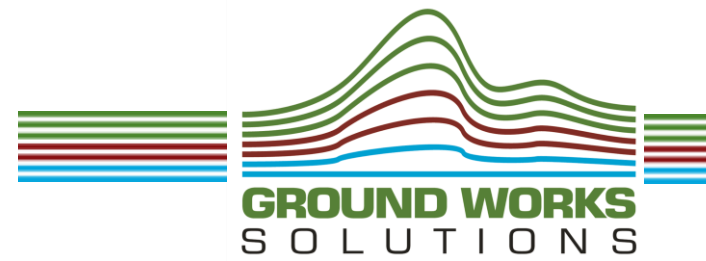
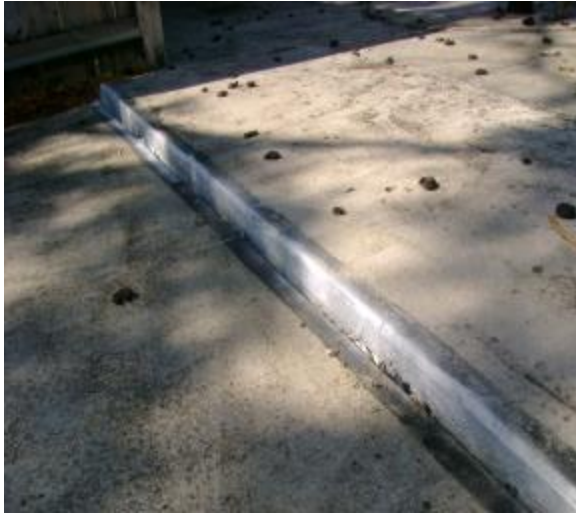
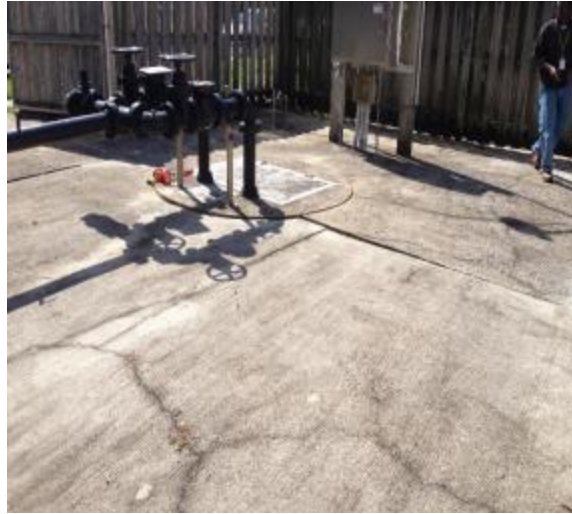
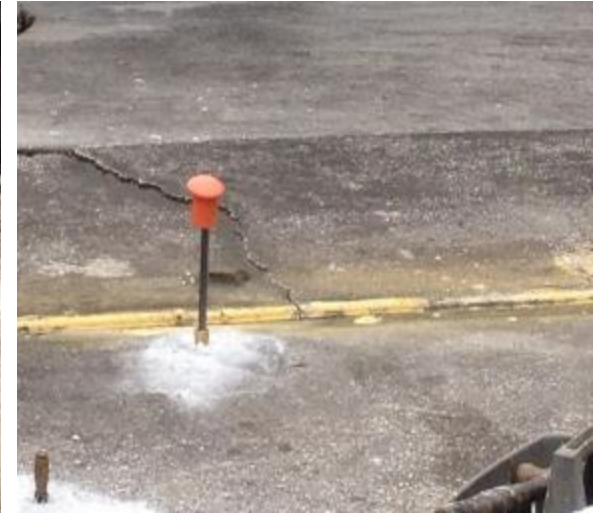
Project Challenges	Solution	Support	Outcome
<ul style="list-style-type: none"> • Poor soil conditions cause base of lift station and approach driveway to settle. • Stabilize base to prevent further settlement • Raise driveway approach 3" 	<ul style="list-style-type: none"> • Inject around pump station to stabilize • Inject under driveway to raise 3" back to grade 	<ul style="list-style-type: none"> • Hillsborough County Public Utilities 	<ul style="list-style-type: none"> • No downtime: All work performed in one day • No neighborhood disruption: No closure to traffic; all work completed during business hours
