ICA and FDOT SR70 Culvert Repair

Highlands County, FL

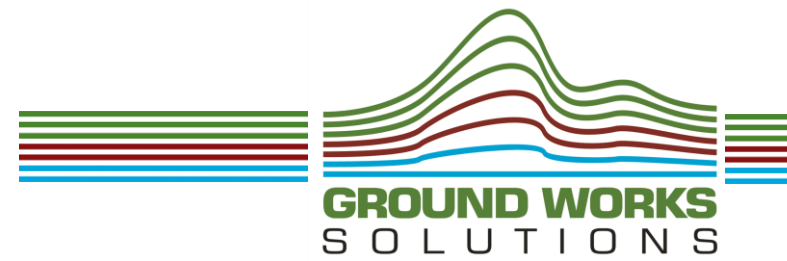
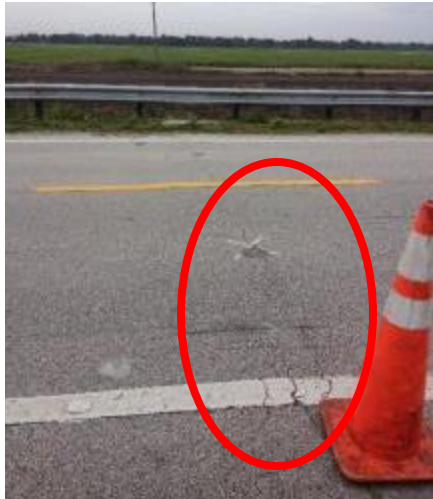
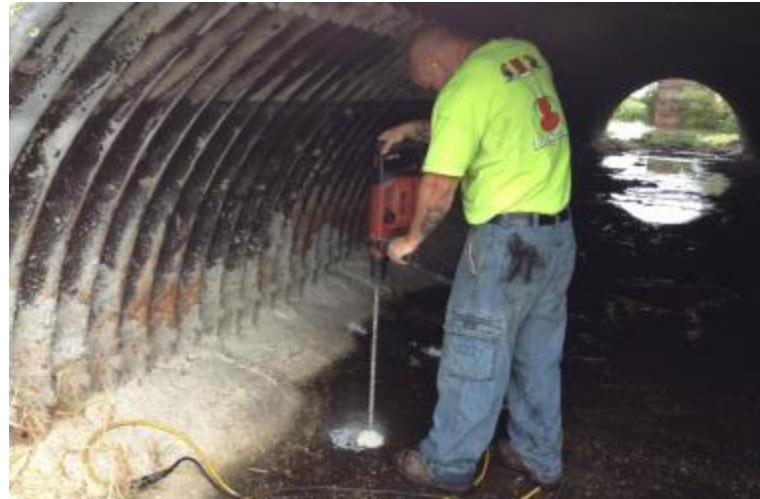
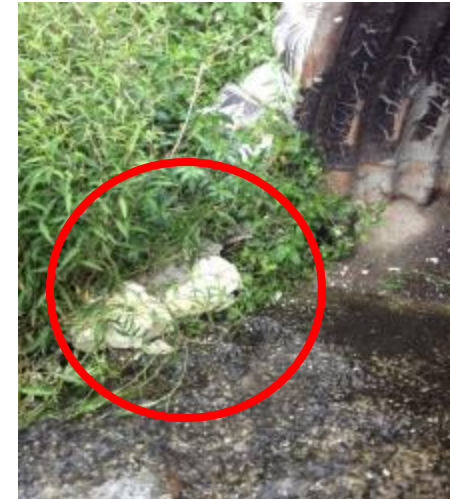
Project Challenges	Solution	Support	Outcome
<ul style="list-style-type: none"> The invert of twin 72" corrugated metal pipe culverts rusted out causing soil erosion under SR-70 in Highlands County CMP failure caused substantial loss of load-bearing soil and highway collapse was imminent 	<ul style="list-style-type: none"> Inject along the base of both CMPs to densify soil, displace water, fill voids, and seal cracks Inject vertically parallel to the highway, creating a "barrier wall" to minimize soil erosion underneath the roadway above 	<ul style="list-style-type: none"> Specifications from ICA and FDOT Designed injection quantity and depth Pre-construction meeting On-site installation 	<ul style="list-style-type: none"> Crisis averted: One day installation resulted in stabilization of culverts and highway with closure of only one highway lane Expenses avoided: Important commercial/agriculture traffic could resume with little disruption
