Ryan Foods

Murray, KY

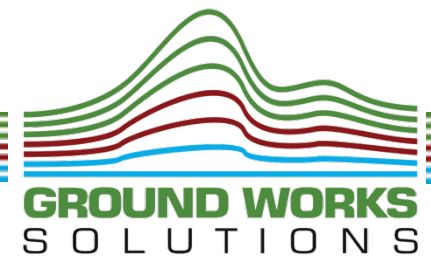
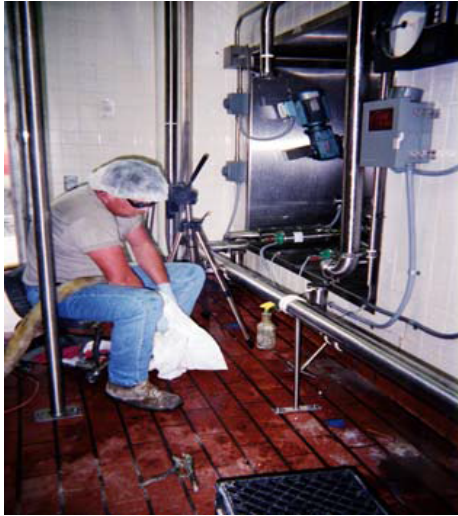
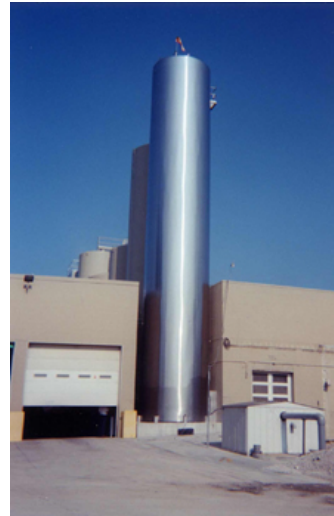
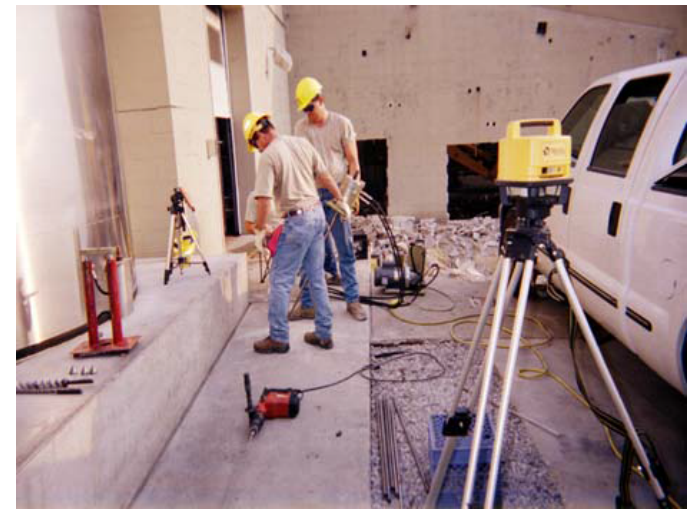
Project Challenges	Solution	Support	Outcome
<ul style="list-style-type: none"> • 50,000 gallon milk tank and foundation pad were settling, also affecting two adjacent buildings. • High water table and fine grain soils (80% passing 200 sieve). • No bearing horizon down to 75' below the surface. 	<ul style="list-style-type: none"> • The URETEK Deep Injection process was used to stabilize and bridge weak soils at two different levels below the pad. • Grouting with Uretek's polymer added just over 7,000 lbs of materials, whereas cementitious grout would have added over 25 tons. 	<ul style="list-style-type: none"> • Designed an injection plan that would allow the densified soils to bridge over the weaker soils at depth, which was the more cost-efficient approach. 	<ul style="list-style-type: none"> • No lost production: The tank was filled and emptied 3x per day while Ground Works worked, and no production was lost. • The tank pad was monitored for 2 years after Ground Works stabilized the soils, and no settlement was observed. • HDR verified no settlement 15 years later! (Dec 23, 2015)
