WaWa Footer Stabilization

Missouri Ave, Largo, FL

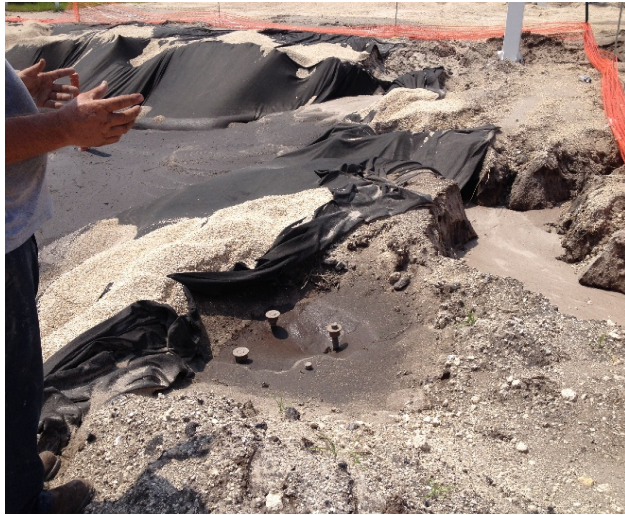
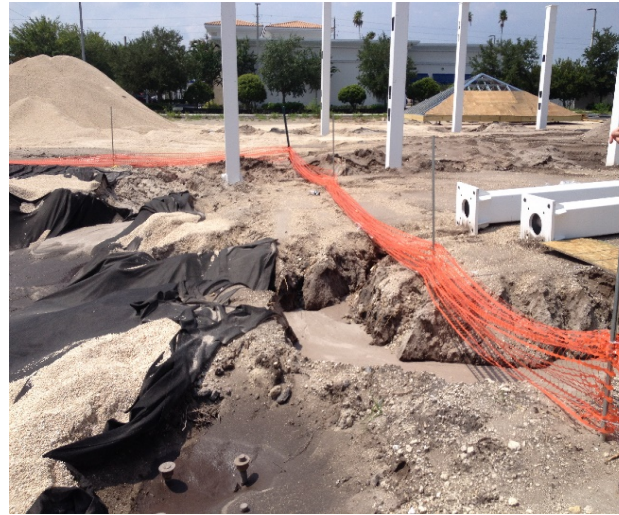
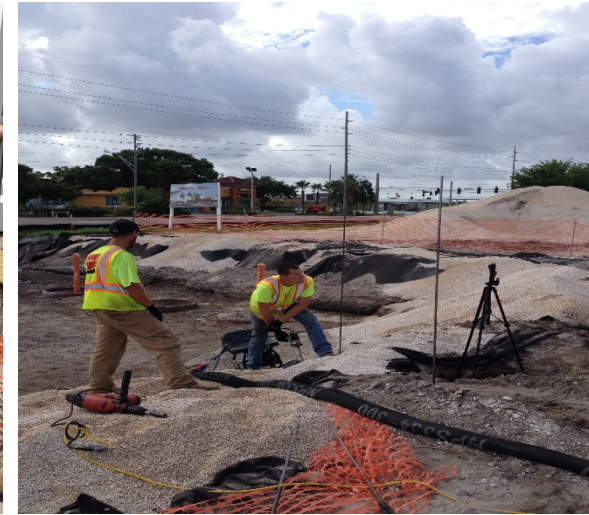
Project Challenges	Solution	Support	Outcome
<ul style="list-style-type: none"> • New construction of a WaWa Service Station • Vibrations from removal of sheet pile between fuel tanks and canopy footers caused 12-ton footer to sink 1.8” • Record rain fall added to poor soil conditions 	<ul style="list-style-type: none"> • Inject around footers to displace water and densify soil to stabilize footers • Attempt to lift footer 1.8” 	<ul style="list-style-type: none"> • WaWa Corporate • AT Construction • Cardno Engineering 	<ul style="list-style-type: none"> • No downtime: All work performed in one day • No Service disruption: Construction continued as work was performed • WaWa engineer satisfied with stabilizing footer, so canopy construction can continue
