Airport Seawall Joint Repair

Orlando International Airport – Orlando, FL

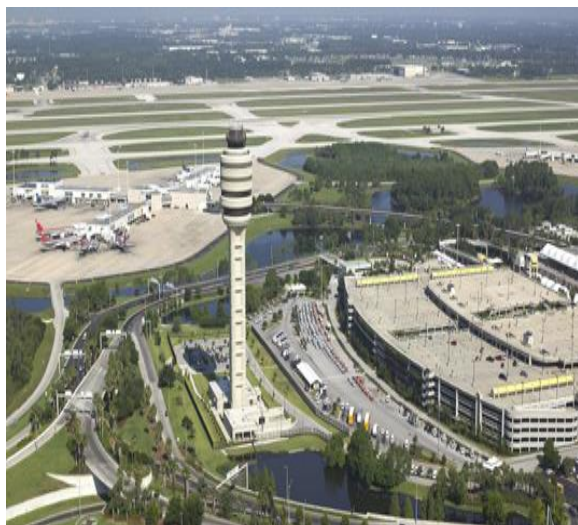
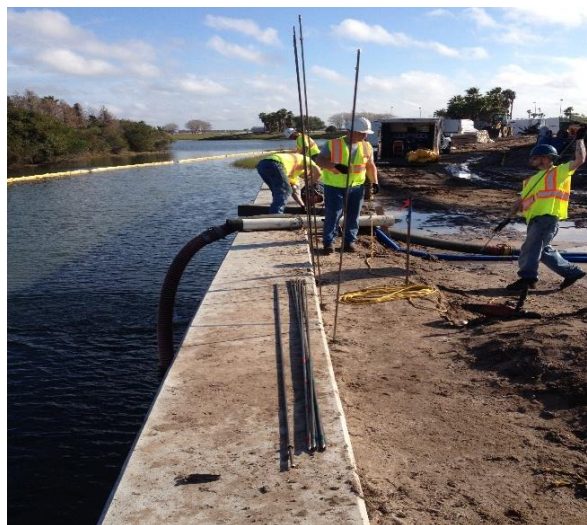
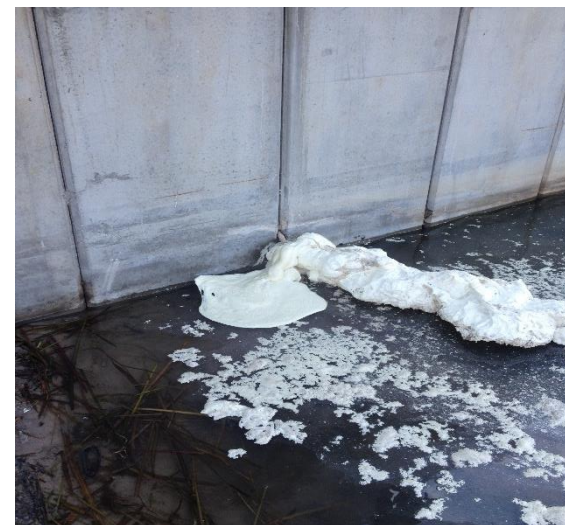
Project Challenges	Solution	Support	Outcome
<ul style="list-style-type: none"> • Active construction site of new chiller plant, just off the SE terminal • Installation of 30" concrete retention wall panels into clay soil compromised the panel joints • Concern backfill behind the wall did not meet FDOT standards 	<ul style="list-style-type: none"> • GWS injected high-density, high-strength polyurethane at joints to densify soil, displace water, fill voids and seal joints. • Injection points were directed toward the joint and wall at various depths to ensure maximum exposure. 	<ul style="list-style-type: none"> • Greater Orlando Aviation Authority (GOAA) • Avcom Engineering • Austin Commercial 	<ul style="list-style-type: none"> • Minimal impact: Work was performed with no excavation. The crew completed work with no interruption to airport or construction operations. • Quick Installation: The project was completed in three days. • Result: Joints were sealed and project came in under budget (~10%)
